RARITAN RIVER BASIN
SOUTH BRANCH OF RARITAN RIVER
HUNTERDON COUNTY
NEW JERSEY

CLINTON MILLS DAM

NJ 00122

**PHASE 1 INSPECTION REPORT
NATIONAL DAM SAFETY PROGRAM**

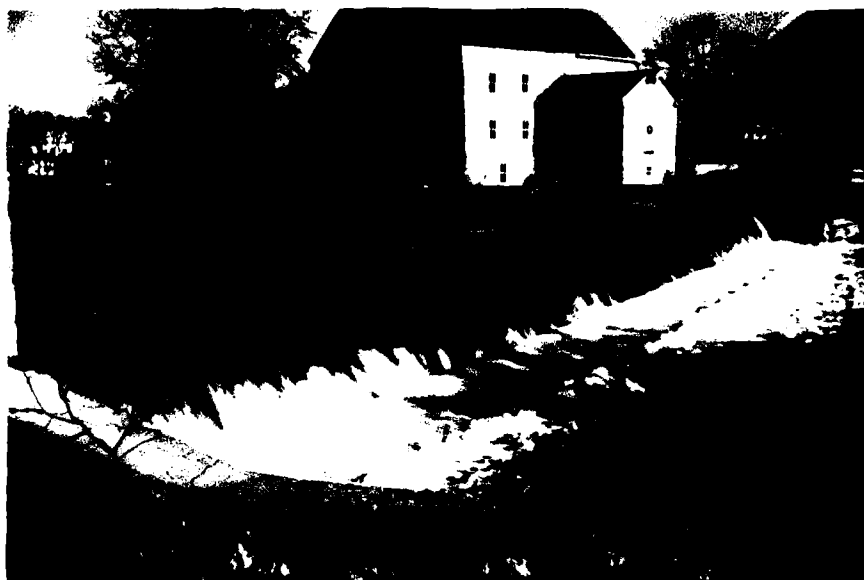
PHOTO 1 28 DECEMBER 1979
SPILLWAY

The dam appeared, at the time of inspection, to be structurally sound. A crack was observed at the left end approximately one foot beneath the crest for a length of approximately 30 feet and was about 1/2 to 3/4 inches wide and 2 inches deep. Also, cracks and minor leakage were observed in the left training wall.

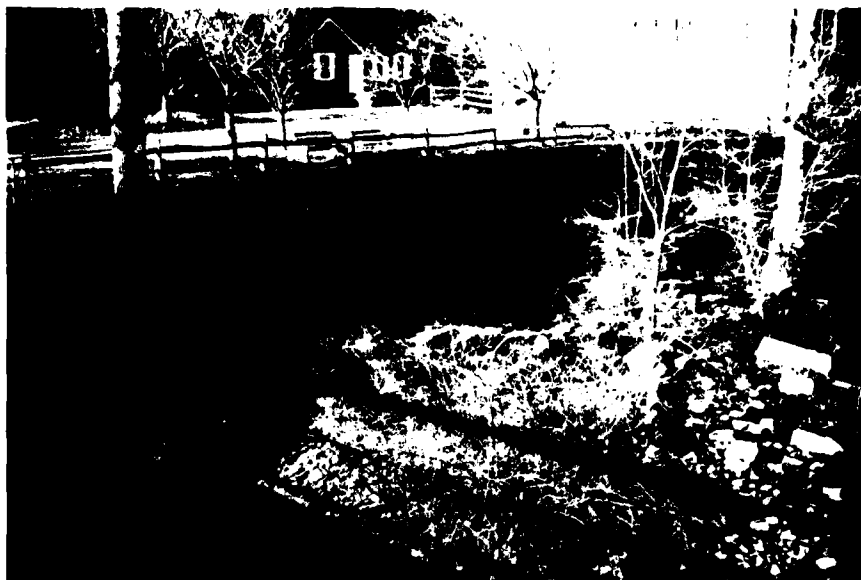
PHOTO 9

TRAINING WALL ALONG WEST EDGE OF DOWNSTREAM CHANNEL
